The Calhan wastewater treatment facility is a minor municipal aerated lagoon system. This system consists of two complete-mix, mechanically aerated lagoons, one facultative lagoon, and an artificial wetland. Subsurface wetlands were included in this wastewater treatment facility to remove suspended solids from

Calhan Facility Statistics

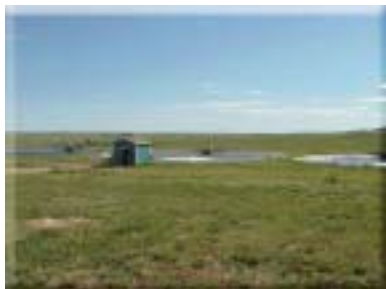
Aerated Lagoons

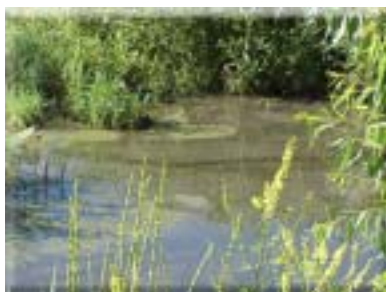
Ponding water in wetland

Slotted pipe is used to convey water from the lagoons to the wetland cells. A 2'x4' water level control is used at this site. No lining was used since the natural soils are clayey. It is noted that the system has settled about 8" to 1' into the clay. This system was designed as a subsurface flow system, but due to settling of the system and possibly plugging, the system operates as a free water surface wetland.

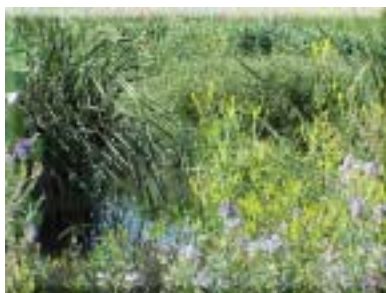
Plant diversity in wetland

The Calhan wetland is comprised of a single wetland cell with two plant communities. The cell is composed of 30 percent water, 20 percent rock, and 50 percent vegetation. Plant community 1, which is 60 percent of the vegetated wetland area, is dominated by cattail (*Typha latifolia*), duckweed (*Lemna minor*), and barnyard grass (*Echinochloa crus-galli*), with a few foxtail barley (*Hordeum jubatum*). Plant community 2, which comprises 40 percent of the vegetated area, is dominated by pinkweed (*Polygonum pensylvanica*), curly dock (*Rumex crispus*), and Canada thistle (*Cirsium arvense*), with plains cottonwood (*Populus deltoides*), crack willow (*Salix fragilis*), and prickly lettuce (*Lactuca seriola*) present but not dominant.

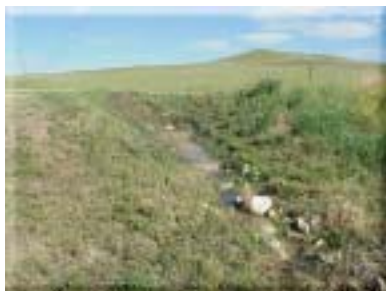
Receiving water body

The wastewater wetland is part of a restricted public access area. The site has been used for educational purposes during field trips by local 4th graders. This wetland has high aesthetic value because it is well maintained and because of its situation on the landscape. The outflow from the wetland flows through a draw, supporting riparian vegetation, then into a stock pond, both the draw and the stock pond provide valuable habitat.
